Dump Truck Debacle

Green Team

Macro-Photography and Initial observations

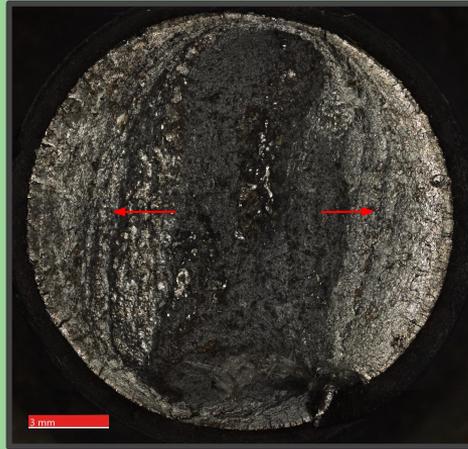
Sample 2

On sample 3 the beach marks start at the original point of the break, however the lines in sample 2 are not beach marks and point away from the final break point

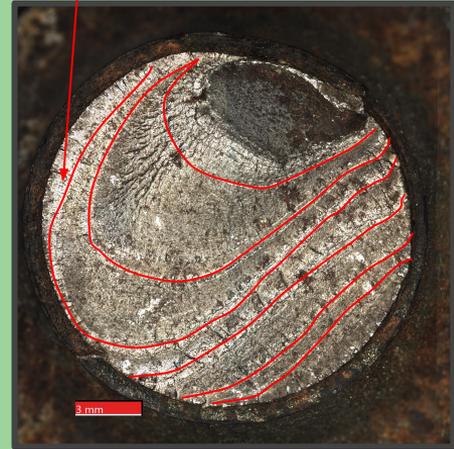
Sample 3

Beach Marks

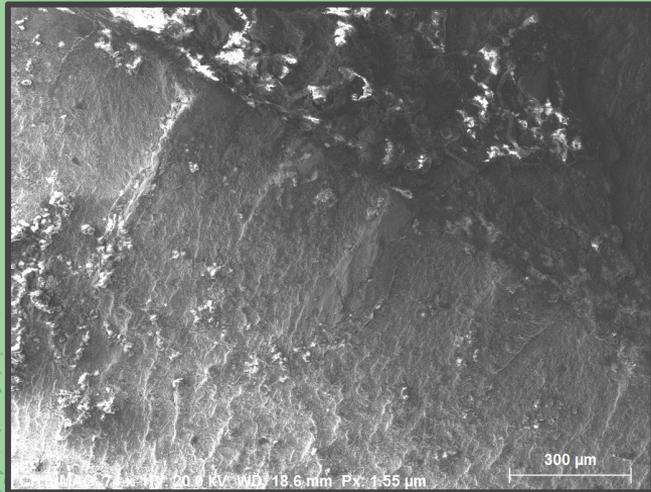
Edge of the fracture surface of sample 3

Ratchet marks, which form when tiny fractures grow and join together

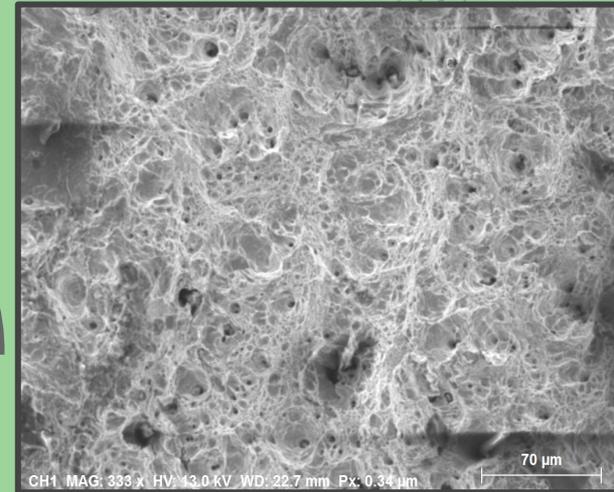
Center of sample 2

Microvoids caused by plastic deformation which points to a ductile fracture

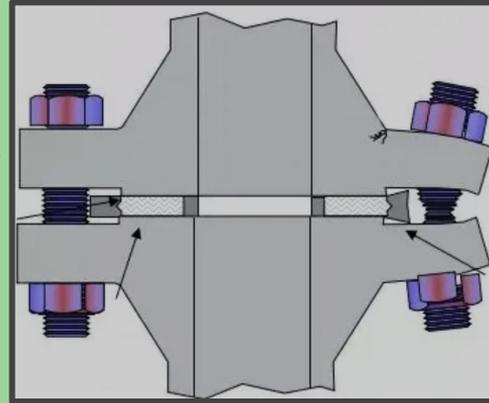
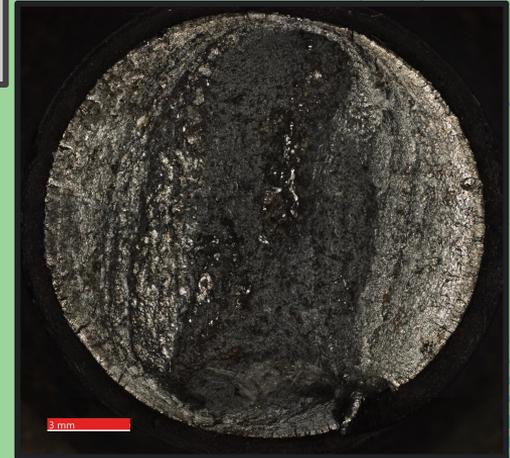
Under-torque Over-torque

- The fracture started with the bolts not getting heat treated properly making them more soft and ductile. 1040 steel instead of 1060 steel
- The bolts were under-torqued.
- Repeated stress on the bolts lead to fatigue
- Improper manufacturing and user error on the torque led to this failure
