Dump Truck Debacle

Green Team

Macro-Photography and Initial observations

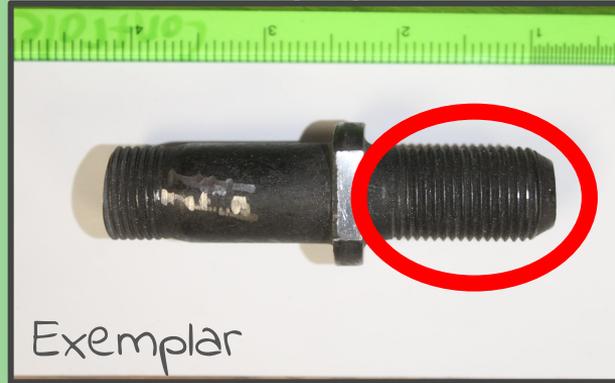
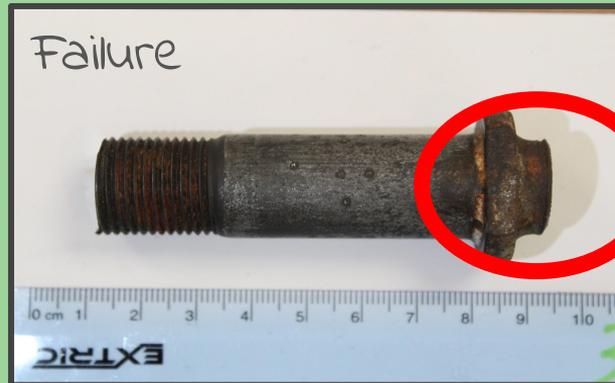
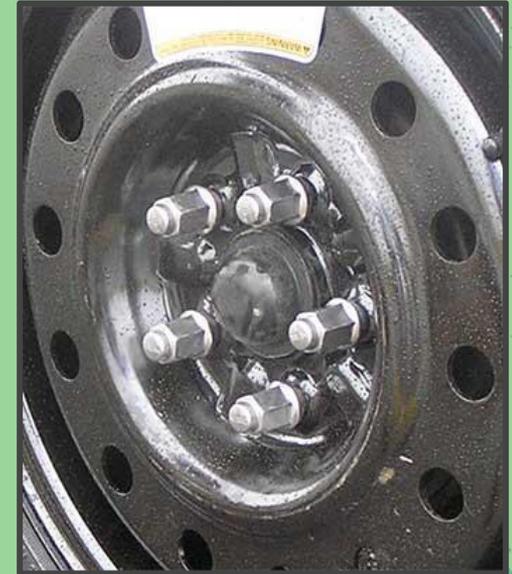
- Tire fell off of garbage truck while driving
- All the studs holding the tire broke
- The tire with the other half of the studs was stolen
- We were given 3 broken studs, 3 slices of the fracture points, an exemplar stud, and some samples of different grades of steel

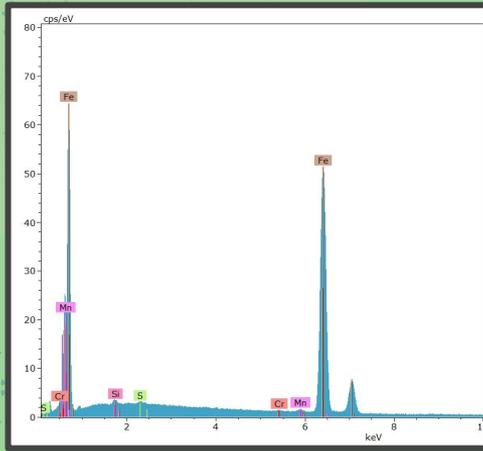
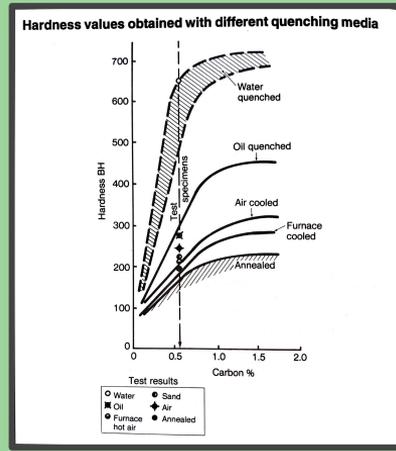
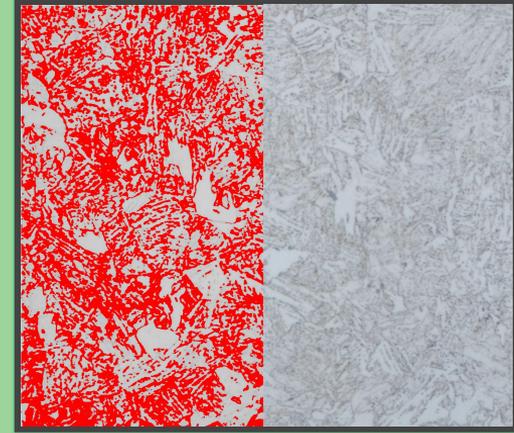
EDS and Carbon Content

- Performed EDS and discovered
 - Primarily Fe, C, Mn
 - Trace amounts of S, Si, Cr impurities
- Quenched and tested the hardness of Sample 1 (430.9 BH) and Exemplar (615.0 BH)
- Found carbon content utilizing the chart above*
 - Exemplar ~ 0.6%
 - Sample ~ 0.4%
- Determined volume phase fraction using point counting
- Utilizing the lever rule, carbon content was confirmed at 0.4%
